**Re: Transmittal of Compliance Evaluation Inspection Report  
Municipality of Guaynabo Small Municipal Separate Storm Sewer System  
NPDES Permit Number PRR040016**

### Water Compliance Evaluation Inspection Report Form (EPA Form 3560-3) Summary of Findings/Comments

Facility Name: Municipality of Guaynabo Public Works Facility  
NPDES Permit Number: PRR040016  
Inspection Date: August 28, 2013

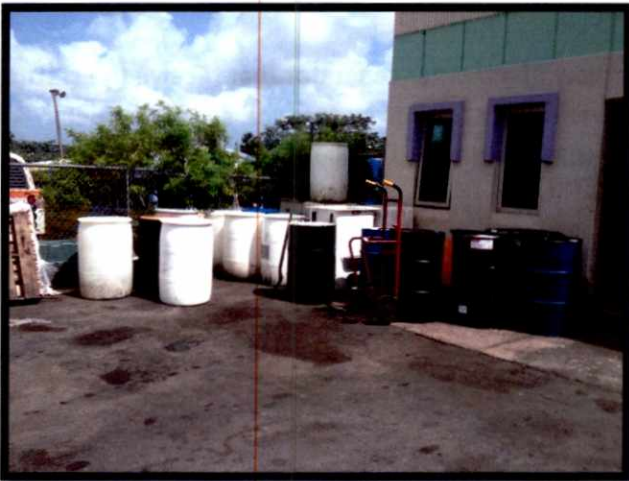
Picture 2

1. The Public Works Facility is bordered by two unnamed creeks at the east and west sides and Rio Guaynabo is located at the north.
2. Several 55-gallon drums were observed in front of the storage area without secondary containment and exposed to stormwater (see Attachment I, picture 2).

View of several 55-gallon drums without  
secondary containment and exposed to  
stormwater. The white drums were identified as  
multi-purpose foaming cleanser and degreaser.

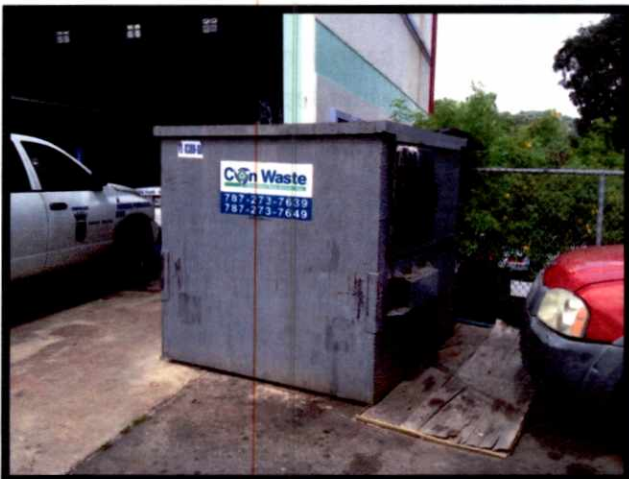
Picture 3

3. An open waste container was observed, exposing the waste to stormwater (see Attachment I, picture 3).
4. Stains were observed on the impervious surface at the east side of the facility. In addition, a 5-gallon bucket was observed filled with used oil exposed to stormwater (see Attachment I, pictures 7 and 8).

View of an open waste container; exposing the  
materials to stormwater.

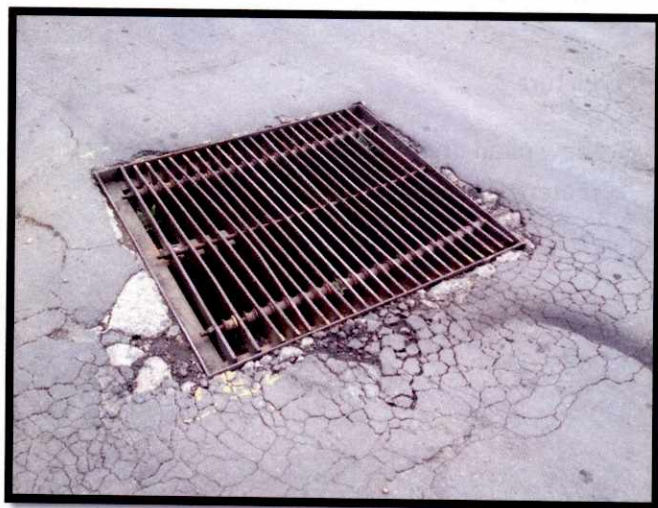
Picture 6

5. The catch basins were in need of maintenance, sediments were observed in most of them. The catch basins observed with sediments were located in front of the oil-water separator, surrounding the fuel station, and the workshop (see Attachment I, pictures 10 and 11).

View of a catch basin in need of maintenance close to the oil/water separator.

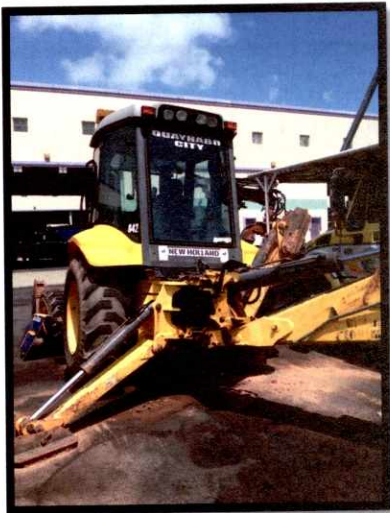
Picture 7

View of vehicles to be decommission with mechanical parts exposed to stormwater and stains on the impervious surface.

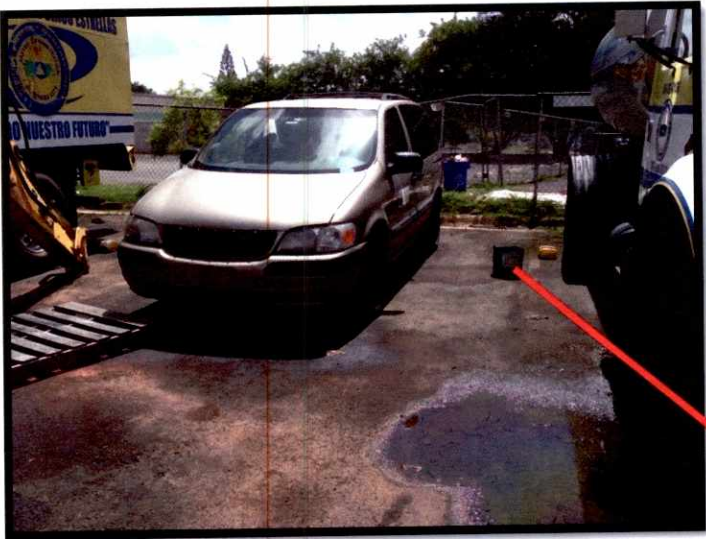
Picture 8

View of vehicles to be decommissioned, stains on the impervious surface, and a 5-gallon bucket filled with used oil exposed to stormwater.

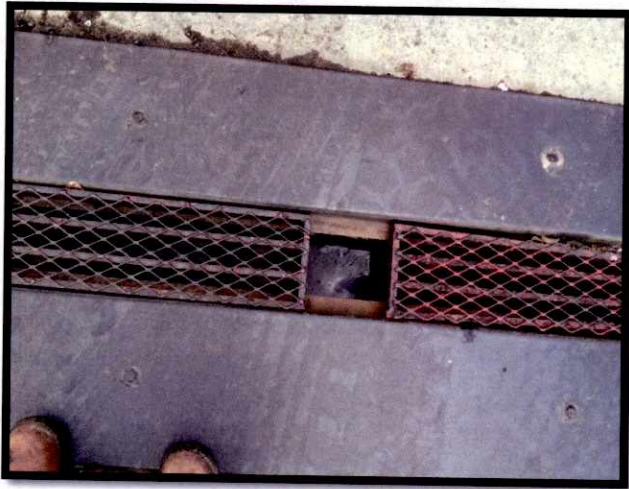
Picture 10

View of the catch basin at the fuel station filled with a dark color liquid.

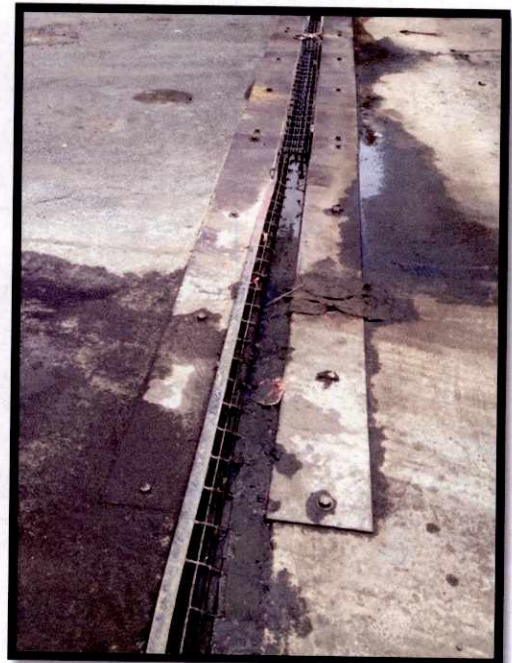
Picture 11

View of the catch basin at the fuel station, it was deteriorated, broken, and filled with sediments.

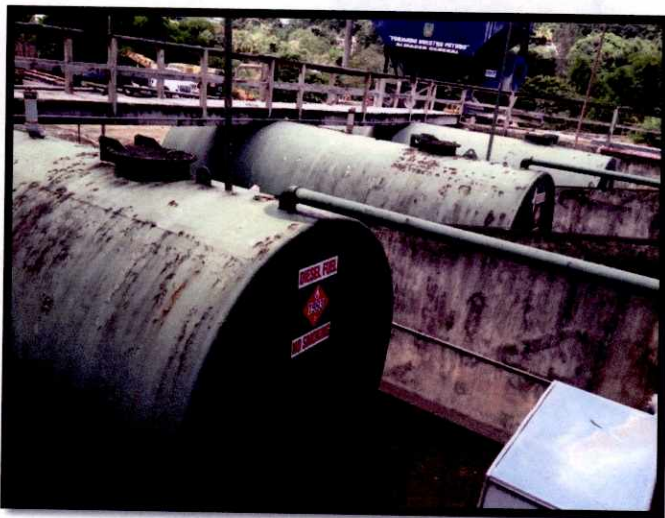
Picture 13

6. The diesel tanks dikes were observed with stormwater and debris.
7. Construction aggregates exposed to stormwater without erosion controls implemented were observed (see Attachment I, picture 14).

View of the diesel tanks dikes filled with stormwater and debris.
